# Engineering Failure Analysis

## Analyzing the mechanisms of fatigue crack initiation and propagation in CRH EMU brake discs

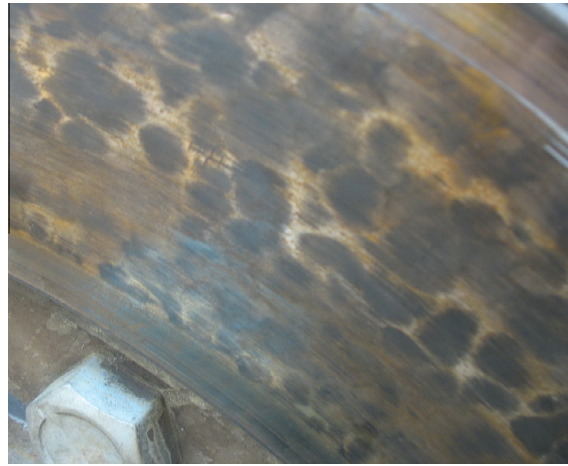
**Fig. 1.** Hotspots on the friction surface.

- (1) The cracks generally initiate in the interior and at the edges of the hotspots. The length of the thermal fatigue cracks is generated in two ways; namely, single crack propagation and multiple crack connectivity.

- (2) With the cracks initiating and propagating, the hotspots on the friction surface are gradually reduced.
- (3) During braking, the exterior of the friction surface is subjected to periodic tensile and compressive circumferential stress which leads to fatigue crack initiation and propagation.

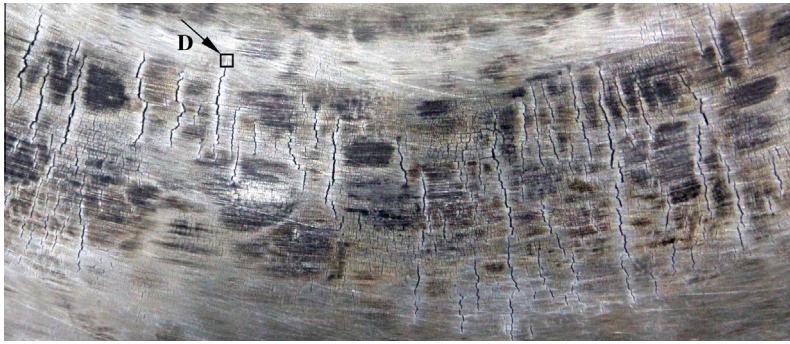
Fig. 3. Closeup view of the local friction surface.

[Fig. 3](#) shows the local friction surface of the brake disc, which withstood a series of braking cycles and had been subjected to higher temperatures. During braking, the energy absorbed by the brake disc was dispersed into two kinds of action. A portion of the energy was discharged in crack propagation, and the rest elevated the temperature of the friction surface.

Through careful observation and analysis, inferences could be made from the photos of the local friction surfaces: the cracks generally initiated in the interior and at the edges of the hotspots; in addition, it has been reported (Ref. [7]) that it is necessary for crack propagation to absorb a certain amount of energy. In fact, the more thermal crack appears in the friction surface, the more energy crack propagation would consume. As a result, the hotspot phenomenon would gradually be reduced, as depicted in [Fig. 3](#).
