Foundation systems of some heritage buildings in Najaf/Iraq case study: Al Shelan Khan

ABSTRACT: The word “Khan” refers to the place where visitors to Najaf city will rest for few days. Historically visitors with their animals, as the only means of transport, usually come to Najaf city in certain religious occasions, rest and settle down in Al Shelan Khan. The Khan was constructed in 1895 by the governor (Wally) Muhammad Mueen Aga during the last years of the Ottoman Empire. The Khan is distinguished by its architectural design and the configuration of the types of columns and arches. The structure has an overall area of 1500 m² consisting of two floors and three basements located at different places in the structure layout. The foundation of the structure is strip type extended approximately 5.5 m below ground level. Bricks of dimensions 22 cm * 10 cm * 4.5 cm are the building units with a mixture of “juss”, lime as binding material. The paper focuses on the overall structural skeleton of the Khan and on the analysis of foundation system.

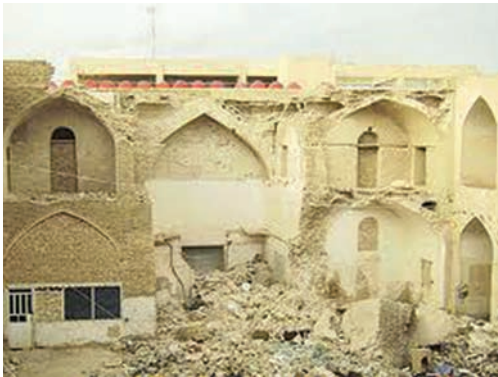
Figure 3. Damaged parts of Khan Shelan.

As many other historical and cultural places the Khan suffers from the lack of rehabilitation and maintenance. During the past decades, it was used by the local people of Najaf in an illegal way. Parts of the ground floor were modified into a number of stores that damaged its architectural presence as a heritage symbol of Najaf city. Parts of the Khan were also subjected to devastation by vandalism actions and many others were damaged due to the long period of different environmental conditions. Figure 3 shows parts of the devastated arches and walls (Shinan 2012).

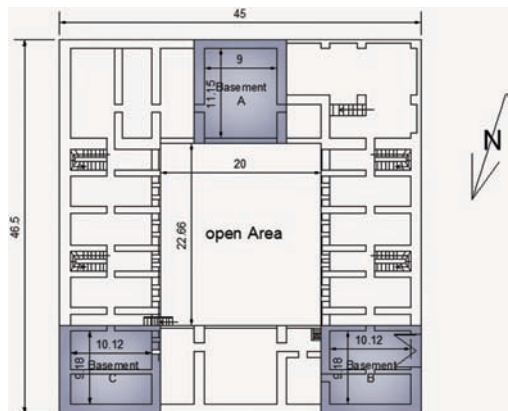
There are three basements extending in depth to about 5 m below natural ground level, two of dimensions 9.18 m * 10.15 m and the other 9 * 11.5 m. Figure 5 shows the location of the basements.

Figure 5. Location of the three basements.

According to the measured dimensions of the structure shown in figures 4, 5, and 6, an estimate was made of the average total applied stress generated from live and dead loads of the different structural elements. The outcomes of the analysis revealed a total stress of 775 kPa on a strip footing 3 m wide. Since the depth of the footing is 5.5 m below natural ground level and the submerged unit weight of the soil approximately equal to 10 kN/m^3 , the net applied stress at base level is determined as

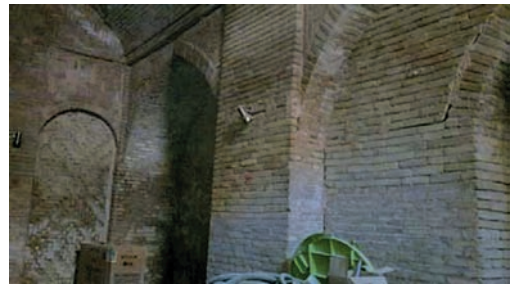
A typical section in basement A of dimensions 9 m by 11.15 m is shown in figure 8. There are two types of embedded columns in the walls; the major ones are 1.06 m * 2.20 m and 2.5 m apart along the long sides and the minor ones are 0.52 m * 2.00 m along the short side, 2.45 m apart. Each two opposite columns support a complete arch, and the number of arches forms the ceiling of the basement. Figure 9 shows the merging of two arches from the top of a column.

Figure 9. Two arches in different directions merging from one column.

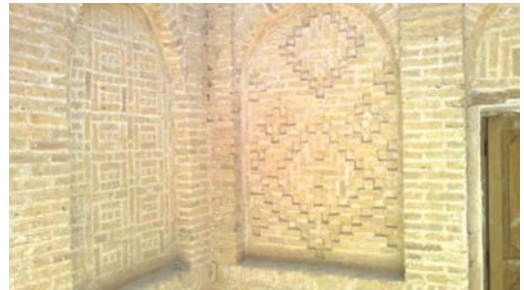
Figure 10. Patterns of decorations on the walls of the basements.

Figure 10 demonstrates the different patterns of decoration observed on the walls of the basement and in many other walls of the Khan, with inner circular arches between the columns. All these decorations were made using the same building unit with perfect measurements and stiles.

Most of the walls in the rooms were constructed with high artistic decoration similar to those shown in figure 10. The working crew was unable to restore and preserve these original fantastic decorations due to the lack of experience and most of these decorations were covered by a layer of "juss" and lime as shown in figure 14.

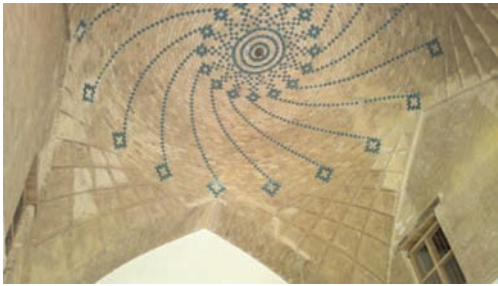
Figure 12. Original decoration of meeting hall 2.

The ceiling of meeting halls has the shape of a dome with real artistic patterns of decorations. The dome of meeting hall 2 remained in its original shape and decoration as shown in figure 12, indicating high quality of artistic proficiency.

Meeting hall 1 was subjected to serious damage and during rehabilitation it was nearly removed and reconstructed using the same size of building units. In spite of the great efforts made by the working crew to get as close as possible, the same decoration of the dome of meeting hall 2, the builders were unable and unsuccessful in achieving the same pattern of decoration as shown in figure 13. The difference in the quality and patterns of decorations can clearly be observed in the two figures.

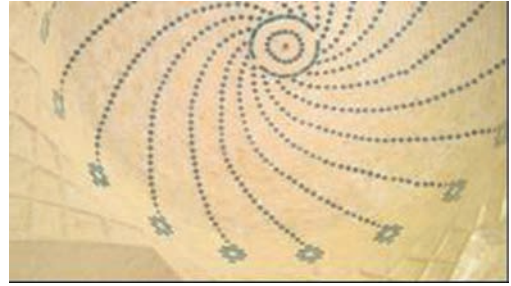
Figure 13. Decorated ceiling of meeting hall 1 after rehabilitation.

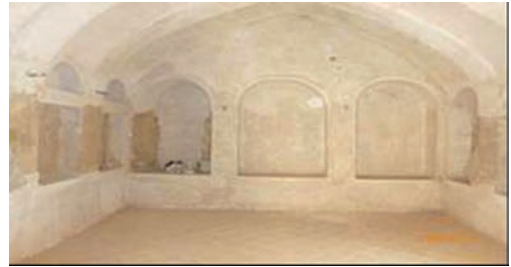
Figure 14. The inside of a typical room after plastering.

depends on the dimensions of the room. These arches act as ribs and the bricks filled the space between them taking the curvature of the arches. Figures 14 and 15 demonstrate the pattern of arches in a typical room after rehabilitation.

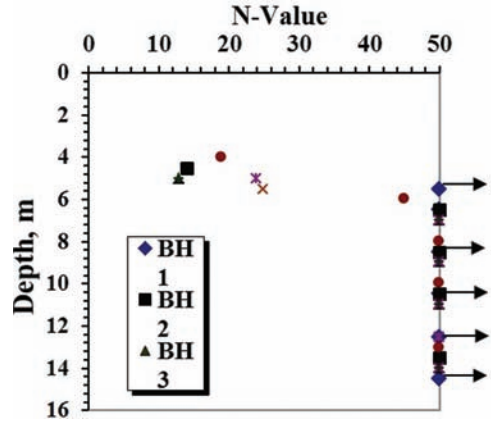
Figure 17 demonstrates that the top 5 m has an SPT-N value between 10 and 30, overlaying a strong layer of SPT-N—value >50.

Figure 17. SPT versus depth.

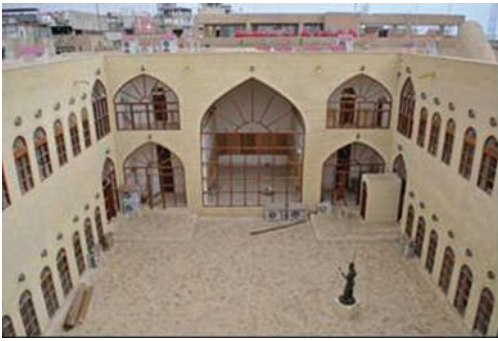
Figure 18. View of the Khan from the inside yard.

The ground floor level experienced some heaving, in the open areas, due to the lack of proper drainage system. Some deterioration of the walls was also observed due to capillary rise. It can be stated that the Khan was damaged by environmental conditions and by local people taking parts of it as small shops and changing its original architectural appearance. Rehabilitation process is in the final stages and figure 18 shows the new appearance of the Khan from the interior open yard.
