# Experimental Study on the Crack Repair Techniques of Concrete Structures: A Case Study

**Abstract:** A crack is a whole or partial split of either concrete or masonry into two or more portions caused by breaking or fracturing in concrete constructions. The bulk of fractures is caused by external forces higher than what the structure or its components can sustain acting on it. The most typical sign of degradation in concrete buildings is cracking. Once the fractured system has been assessed, an appropriate repair method that considers these reasons may be chosen. Selecting the best crack repair method may produce results that endure for a very long time while saving you a lot of time, money, and effort. The causes of cracks and several strategies for healing them are covered in this paper.

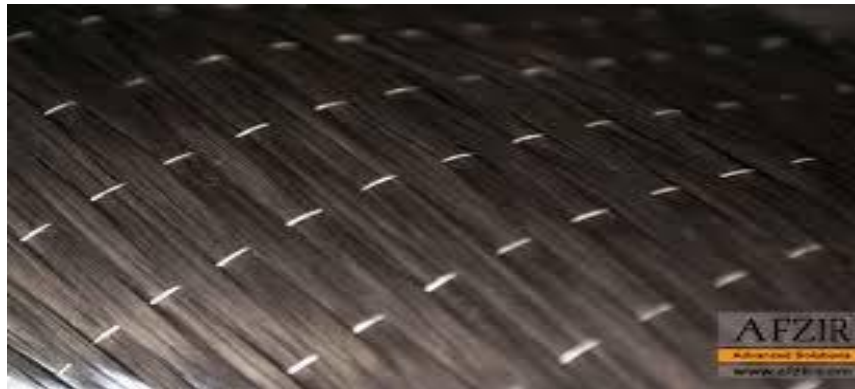
**Figure 1.** Carbon Fibre Reinforced Polymers

Using materials made of carbon fibre-reinforced polymer (CFRP), which is lightweight and robust in Spans, is beneficial when creating improvements in structural engineering. The utilization of superstructures as a retrofit approach is becoming progressively well-known. While having a great deal of knowledge of the program, using CFRPs for primary applications is gradually typical.

It has been gotten about structural designing, and considerably fewer CFRPs have been utilized to fix an assortment of designs <sup>[13]</sup>. In recent years, the Use of Carbon Fibre Reinforced Polymer (CFRP) materials in woven and laminated forms to retrofit these corroded R.C. structures. CFRP material is lightweight, corrosion-resistant, and has high tensile strength <sup>[21]</sup>. They can also quickly bond to concrete surfaces without scaffolding or large jacks and with minimal support. The CFRP system can also be used in areas where traditional procedures would be difficult to apply due to limited accessibility. As a result, CFRP repair technology makes upgrades more accessible and saves money <sup>[17]</sup>.

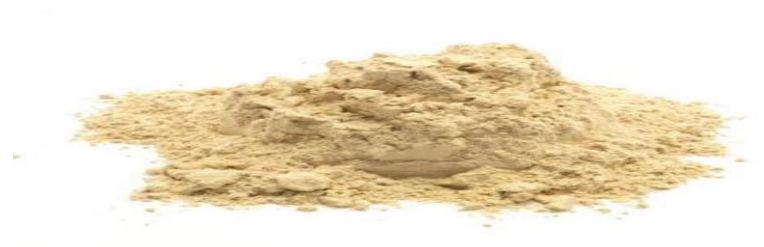
**Figure 2.** Bacillus subtilis spore powder

Microbes, explicitly *B. subtilis*, were chosen for this examination since they meet the essential boundaries to make due in brutal conditions. Whenever Gram-positive microorganisms are presented with antagonistic conditions, they can deliver spores. This spore arrangement safeguards the life form against high mechanical pressure and antacid conditions, making it a great decision. Individuals from the class *Bacillus* can deliver spores that can stay lethargic for over 200 years <sup>[22]</sup>.

A spectrophotometer with a frequency of 600 nm was utilized to gauge an amount of 0.5 ml of the precise arrangement. The clear was supplanted with 0.5 ml of the bacterial account after the instrument perused the clear, and the 600 nm frequency was reused <sup>[19]</sup>. Bacterial arrangements (microorganisms in a culture tank), created and handled in a controlled microbial science lab to guarantee spore creation, are regularly used to bring these microscopic organisms into processes in different substantial blends <sup>[23]</sup>

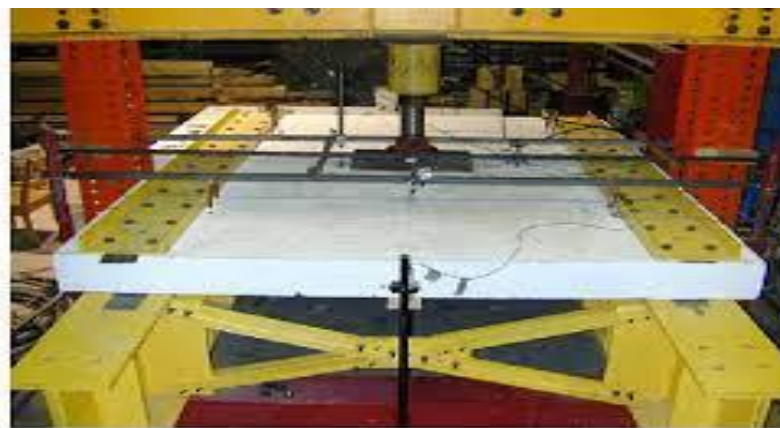
**Figure 3.** Test setup

Six full-scale, 2.8-meter-long one-way reinforced concrete slabs were used to study how various repair methods affected the structural response of one-way slabs. Cast, cured, and tested components are 1.2 m broad and 0.2 m thick. Five high-yield deformed steel bars with a diameter of 10 mm and a characteristic strength of 460 N/mm<sup>2</sup> make up the steel reinforcement. The concrete used has a 28-day compressive strength cube of 30 N/mm<sup>2</sup>. As illustrated in Figure 3, a two-line load is applied to the central part of each specimen during testing. Except for the control slab, which is stressed till failure, all the slabs are initially loaded to 2/3 of their projected ultimate load capacity or when the specimens begin to show indications of cracking. [5].

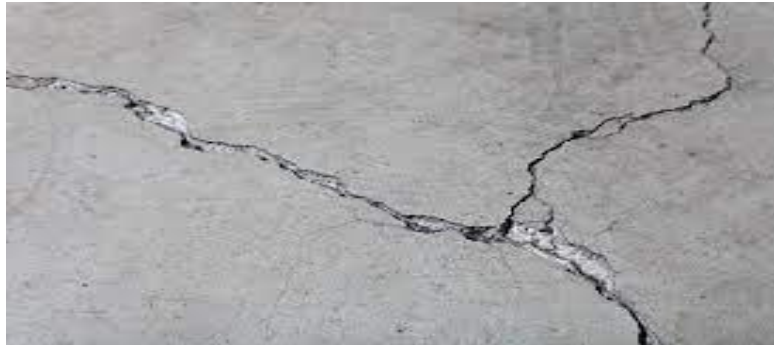
**Figure 4.** Cracks in slab

Under a total load of 37.4 kN, two flexural fractures measuring 0.60 mm in width each were seen at the centre third of the slab. This restoration technique uses 200 mm-diameter injection nipples along the crack's route. The injection nipples were secured in place, and the surface of the fissures was sealed with Sikadur30. Sikadur52, a low-viscosity epoxy that is free-flowing, quick to cure, and based on a two-component solvent-free epoxy resin, is used to plug the fracture. Its properties include 1.1 kg/L density, 25 N/mm<sup>2</sup> tensile strength after seven days, and 40 MPa compressive strength after 24 hours at 20 C. Sikadur52 puts width limitations on cracks between 0.2 and 5 mm. The crack was filled

with Sikadur52 by injecting it from one end until it began to seep out of the other nip. Epoxy resin was injected into the cracks until they were filled.

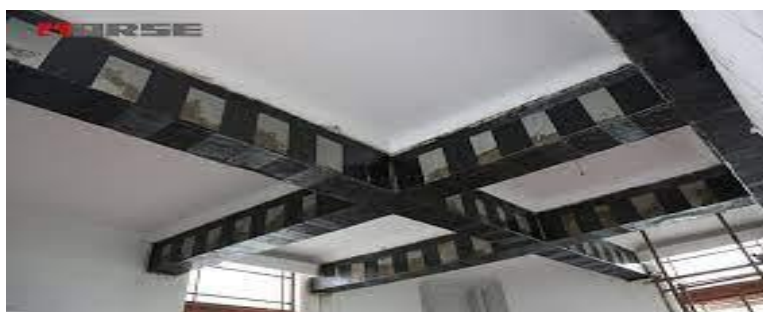
**Figure 5.** CFRPs in beams

A beam with a cross-section of 150x300mm and a length of 3350 mm was manufactured for testing. The beams are supported and loaded in flexural loading under two points loading circumstances after 28 days of cure. The fractures in unrepaired beams were tested. [15]. Three half-scale models of the inner floor column connections are exposed to a rising lateral load routine daily while being subjected to the ground load of the floor slab and beam, equivalent to dead load + 30% live load. Damaged specimens are fixed to the plate surface with an epoxy-based crack sealant and gravity-fed CFRP sheet and then subjected to the same loading technique<sup>[20]</sup>.

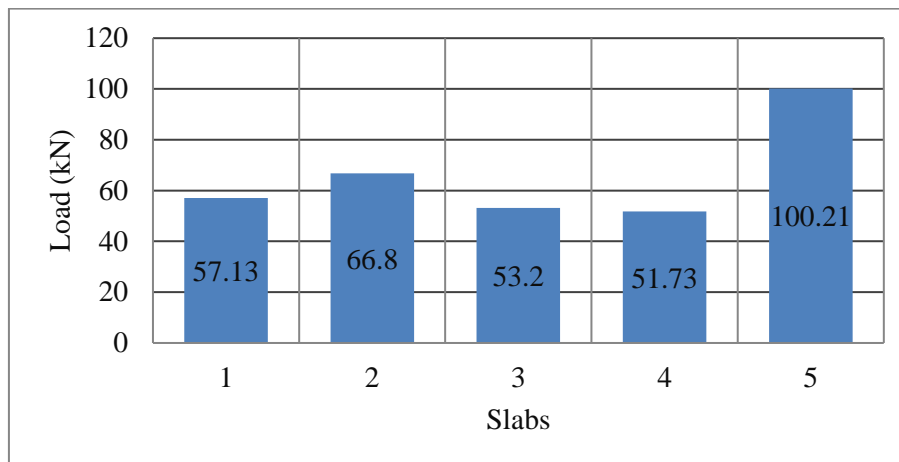
**Figure 6.** Cracking loads for slabs

The initial cracking loads for slabs are shown in fig 5. The repaired specimen using epoxy injection techniques shows 35% increased cracking stresses compared to controlled slabs [5].

Fig. 6 displays the control slab and various reinforced concrete slab specimens' first cracking loads (S1). All rehabilitated concrete slabs, except for S5, exhibit higher cracking loads than the control slab. Cracking loads in the restored specimens utilizing grout pouring, epoxy injection, and section expansion procedures are 35% higher than in the control slab. In comparison, adding a layer of Ferrocement raises the cracking load by 17.8%. Reinforcing the slab by putting CFRP at its soffit does not strengthen the initial cracks; instead, it further widens the breach. Except for specimen S3, where the cracks were sealed with epoxy, all of the repair techniques used in this study can be demonstrated to be successful in restoring the damaged slab's ultimate capacity. However, the strength loss is just 8.6% compared to the control slab. The slabs S5 and S6, which were repaired using CFRP and section expansion, respectively, have ultimate load capacities of 77.4% and 130% greater than those of the control slab. The increase in maximum strength for slab specimen S5 is equivalent to that reported by Toong and Li [5], despite the comparatively low ratio of CFRP strip area to the total cross-section utilized in this experiment.
